Structural inspection and external refurbishment at St. Ives Service Reservoir

Service/product: Water tower refurbishment | **Customer:** South Staffs Water

Location: St. Ives Service Reservoir, Cambridgeshire, UK

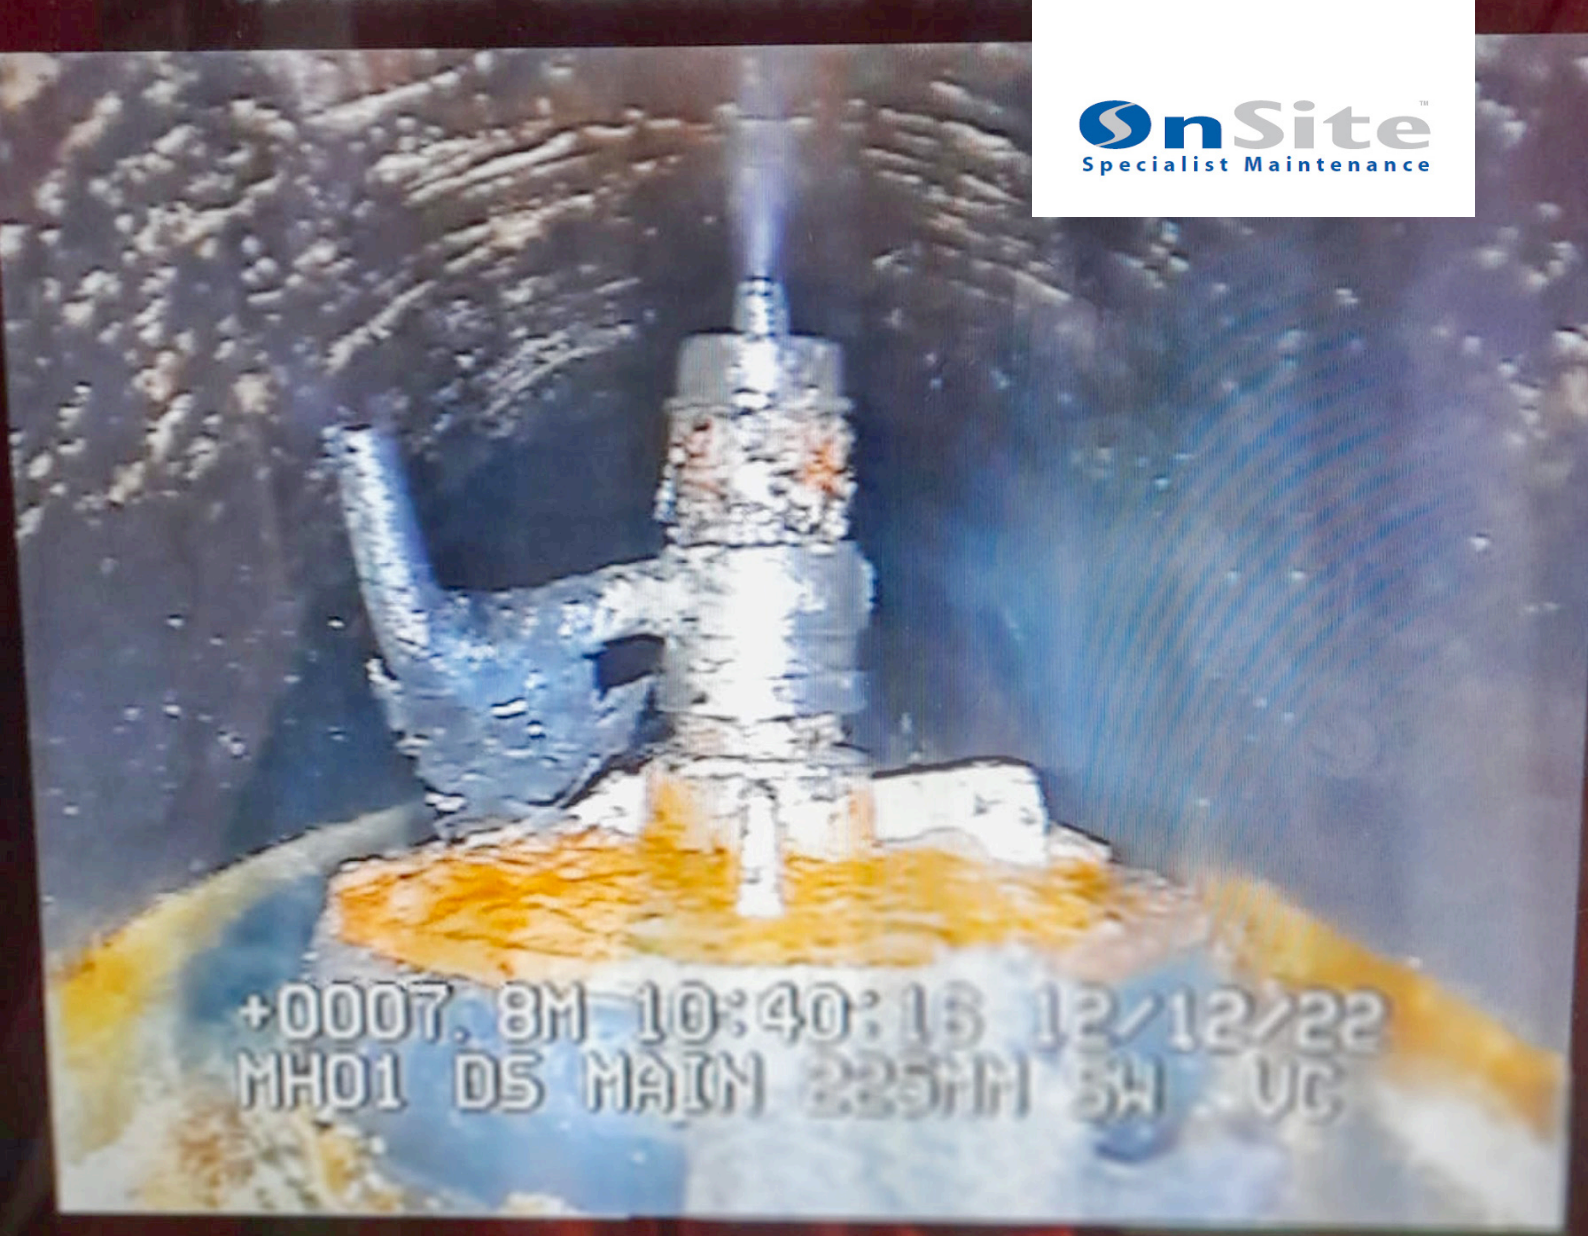
+0007. 8M 10:40:15 12/12/22
MH01 DS MAIN 225MM SW UC

A CCTV survey showing an obstruction within the discharge pipe.

With the assistance of our sister company, OnSite Central, we carried out a camera inspection of the overflow pipework. This uncovered a bung inside the pipe that was causing a blockage to the discharge pipe. After several discussions it was decided that a robotic cutter was the best option to remove the bung. This was used to cut the bung into several small manageable pieces which were then removed from the pipe ensuring a successful removal.

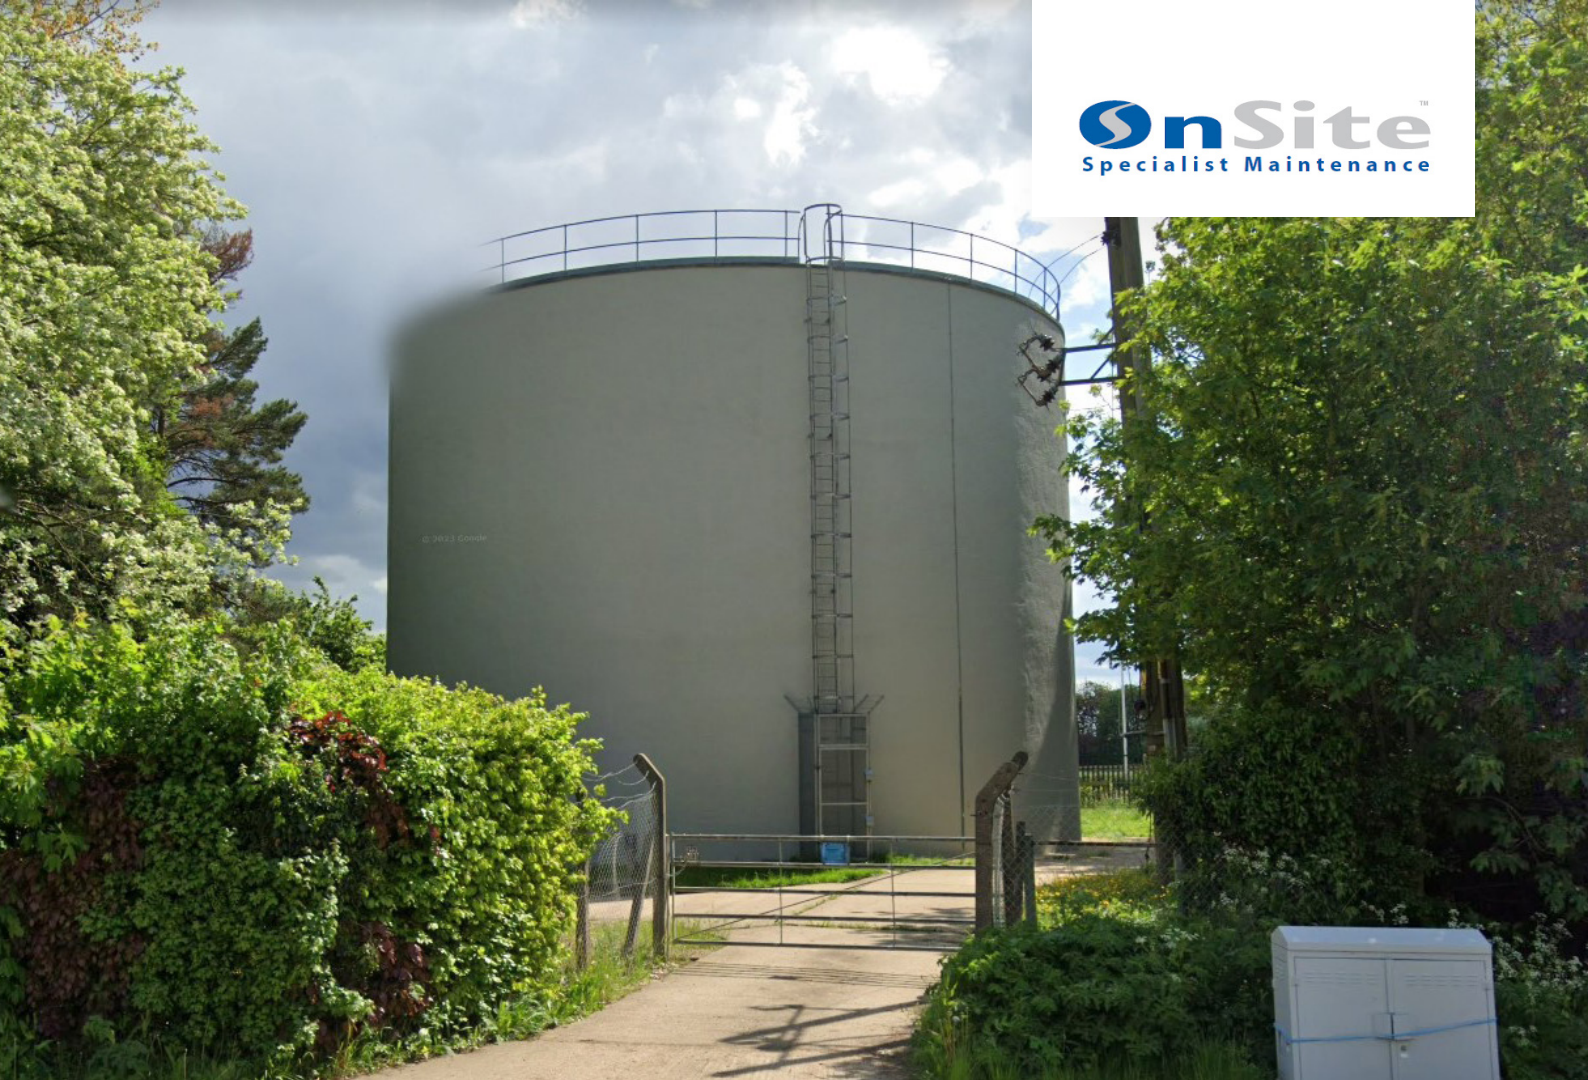
Water tower after a thorough cleaning and anti-carbonation coating to all external surfaces.

The external works comprised the excavation and removal of rubble around the perimeter, cleaning the reservoir wall and removal of graffiti using a high-pressure, hot water doff unit. A waterproof, protective, anti-carbonation coating was applied to the base of the wall which was then backfilled with new material. By using an MEWP, the entire structure was coated to ensure it remains protected and durable.
